# **City of Minnetonka**

## **Americans with Disabilities Act**

### **Transition Plan for Public Building Facilities**

November 2024

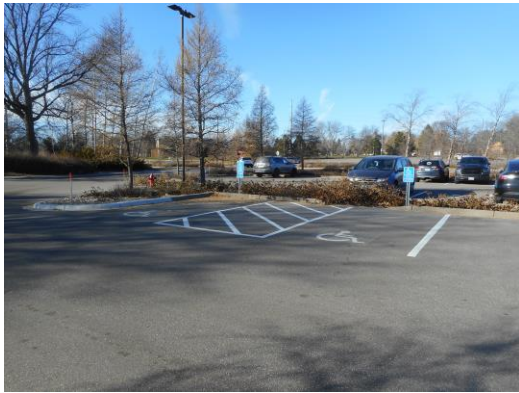
**Photo 1:** Accessible parking spaces have been designated near the main entry. *This is a good example of accessibility.* Additional recommendations include raising the signs to 60"-66" (measured to the bottom of the sign above the parking surface); currently at 33".

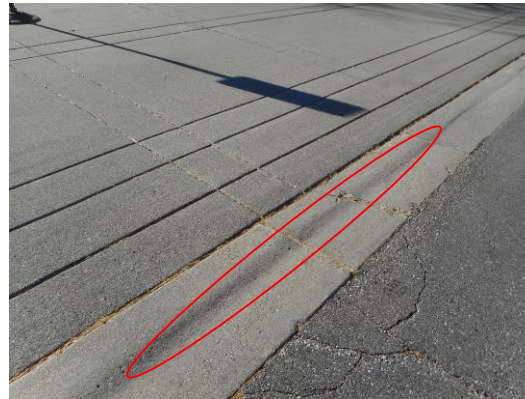
**Photo 2:** A flush curb is provided along the full width of the sidewalk leading to the entry. *This is a good example of accessibility.* Currently there is an abrupt rise and short (~3") steep section along the gutter (>21% vs. 8.33% maximum).

Exterior Route:  
 Modify the gutter along the curb ramp  
 Patch and fill openings between sections of concrete  
 Stripe a crosswalk from parking to entry

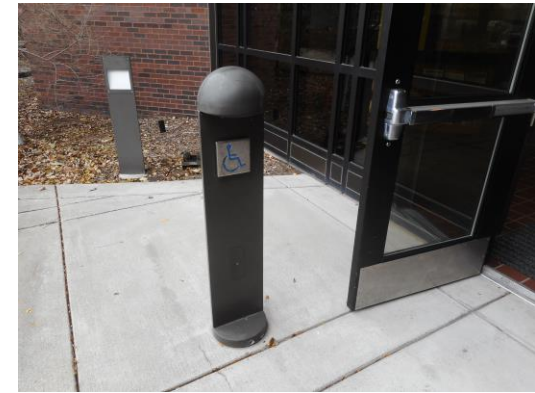
**Photo 3:** A power door opener is provided at the main entry. *This is a good example of accessibility.* Currently the arc of the door swing overlaps the clear ground space at the control button.

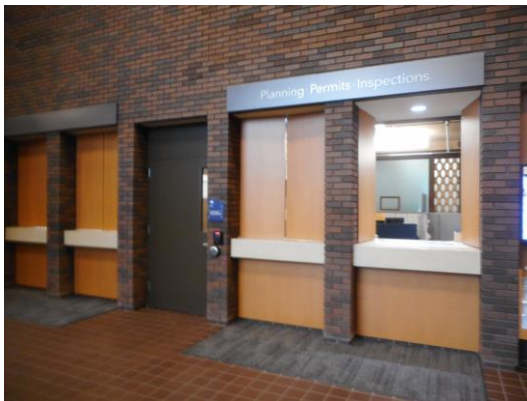
**Photo 4:** Service counters for City Clerk, Planning / Permits / Inspections and Utility Billing & Assessing are currently at 42" AFF (vs. 36" maximum).

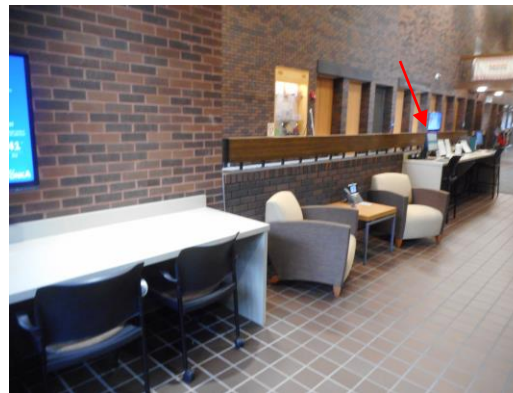
**Photo 5:** There are 2 public computers located in the lobby; currently both computers are located on a high counter at 36" AFF (vs. 28"-34" for a work surface). An accessible section of work surface/counter is located within the same lobby area, but there are no computers at that location.

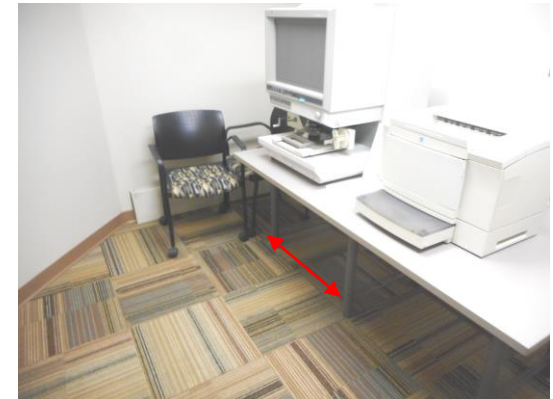
**Photo 6:** A microfiche machine is located in the lobby. The table holding the microfiche currently provides 25" high knee clearance that is only 28" wide (vs. 27" high minimum and 30" wide minimum).

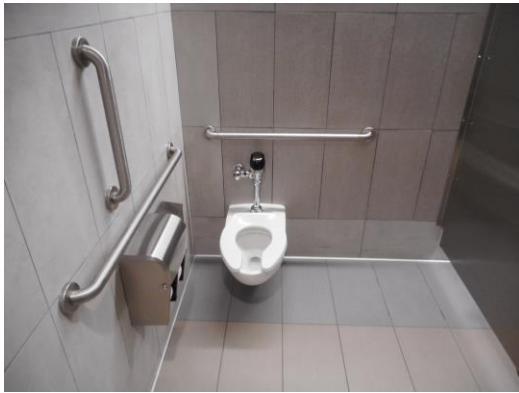
**Photo 7:** The multi-fixture toilet rooms on both levels have been remodeled and features of accessibility were incorporated. *This is a good example of accessibility.*

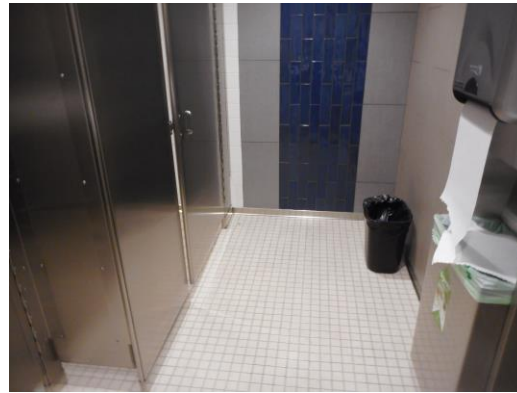
| Location<br>JQP # / Item # | Solution / Comments | Qty | Unit Cost | Total Cost | Priority | Estimated<br>Compl. Date | Person<br>Responsible | Actual<br>Compl.<br>Date | Actual<br>Cost |
|---|---|---|---|---|---|---|---|---|---|
| 22J1 27790 | Reconfigure stalls to provide a minimum 48" approach to the toilet stall door. If toilet stall approach is from the latch side of the stall door, clearance between the door side of the stall and any obstruction may be reduced to a minimum of 42".<br>ICC / ANSI 604.9.3<br><i>The approach to the accessible compartment is reduced to 41" (vs. 42" minimum) due to the towel dispenser. Replace the towel dispenser with an alternate style that does not project as far into the circulation route. Photo 8.</i> | 1 | \$200 | \$200 | 4 | | | | |

**Photo 8:** In the lower-level women's toilet room the towel dispenser/waste receptacle unit reduces the width of the maneuvering clearance on the pull side of the accessible compartment door.

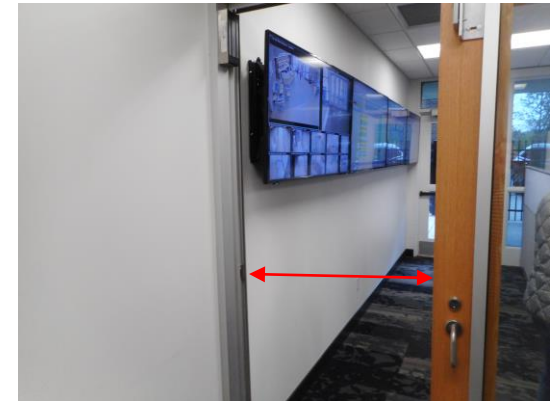
| Location<br>JQP # / Item # | Solution / Comments | Qty | Unit Cost | Total Cost | Priority | Estimated<br>Compl. Date | Person<br>Responsible | Actual<br>Compl.<br>Date | Actual<br>Cost |
|---|--|---|---|---|---|---|---|---|---|
| 14G2 27784 | Remove, relocate or replace object so it does not protrude into the circulation path.<br>ICC / ANSI 307.1<br><i>The wall mounted TV/Security monitors protrude 6" at a height of 56". Photo 9.</i> | 1 | \$100 | \$100 | 4 | | | | |

**Photo 9:** The sliding door to the IT and security office provides a 31" clear opening (vs. 32" minimum) due to the electronic door lock mounted on the top. The TV monitors within the space protrude 6" into the circulation route (vs. 4" maximum).

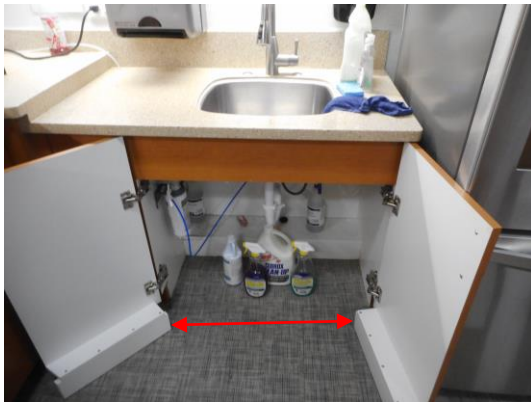
**Photo 10:** A sink with a forward approach is provided in the employee break room (a parallel approach is not possible due to the depth of the adjacent refrigerator). *This is a good example of accessibility.*  
The width of the clear floor space is only 29" (vs. 30" minimum) due to the toe kick detail.

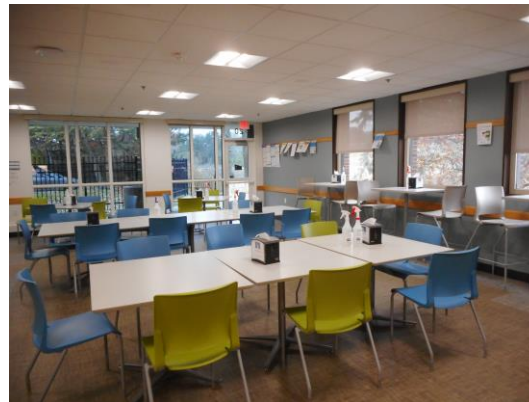
**Photo 11:** The tables within the break room are tall/bar height tables or low tables with a pedestal style base that obstructs toe clearance. There are not currently accessible dining tables within the break room.

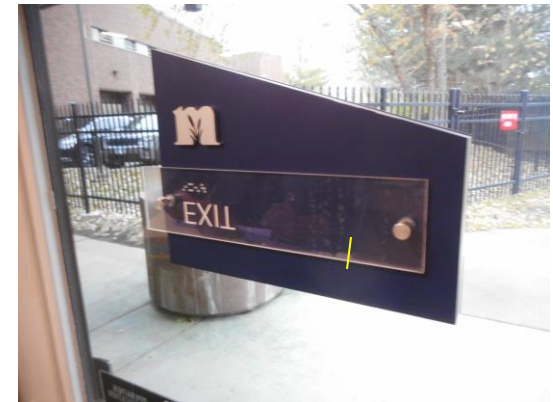
**Photo 12:** The sign stating "Exit" from within the break room is installed backwards, with the tactile and braille characters facing the in to the wall (as well as the "T" being upside down).

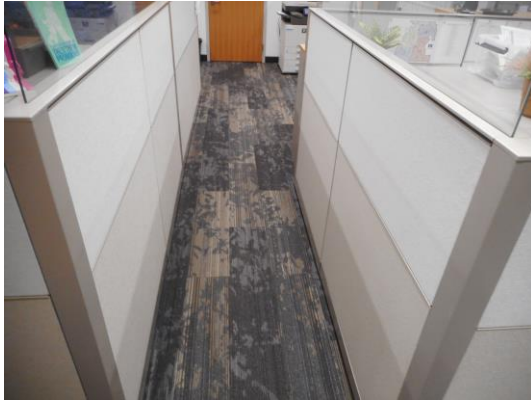
**Photo 13:** The distance between the cubicle partitions within the Administration office is 35" (vs. 36" minimum).

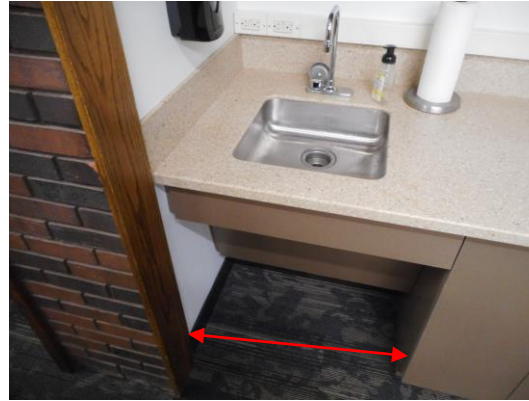
**Photo 14:** At the coffee station with the Community Development department a sink with a forward approach is provided (a parallel approach is not possible due to the adjacent wall). *This is a good example of accessibility.* The width of the clear floor space is only 29" (vs. 30" minimum) due to the trim detail on the brick wall.

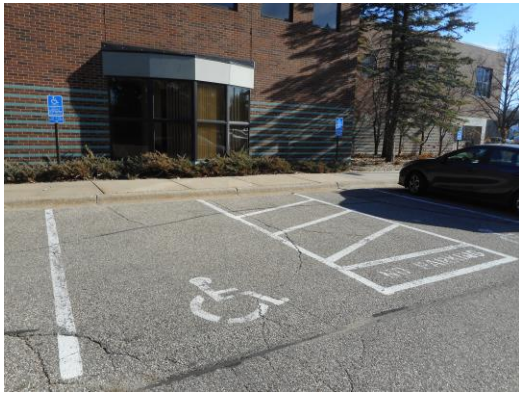
| Location | Solution / Comments | Qty | Unit Cost | Total Cost | Priority | Estimated<br>Compl. Date | Person<br>Responsible | Actual<br>Compl.<br>Date | Actual<br>Cost |
|--|---|--|---|---|---|---|---|---|---|
| 05D2 | 27902 | Provide a permanent, upright sign that complies with MN Statutes 169.346, including information about fines. MN 1341 502.7<br><i>Currently 2 of the spaces to the north are missing signs. Photo 1.</i> | 2 | \$250 | \$500 | 2 | | | |

**Photo 1:** Accessible parking spaces have been designated near the main entry. *This is a good example of accessibility.* Currently 2 of the spaces are missing signs designating the accessible parking and 3 of the signs are not centered on the parking space.

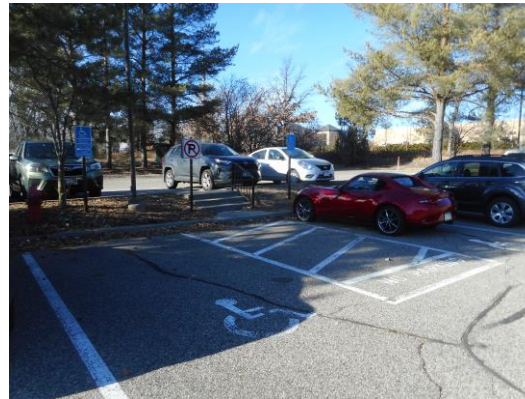
**Photo 2:** There are 2 parking spaces designated that face west; the aisle aligns with stairs from the upper portion of the parking area. These spaces are not located on the shortest accessible route to the main entry.

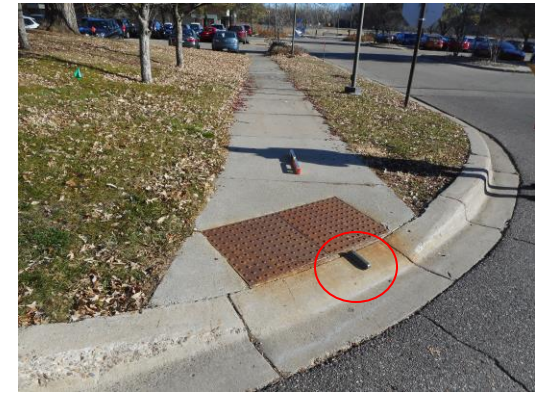
**Photo 3:** Curb ramps are provided in order to create an exterior pedestrian route from Williston Rd. to the main entry. The existing curb ramps are in rough condition and have up to 30% slope along the gutter at some locations.

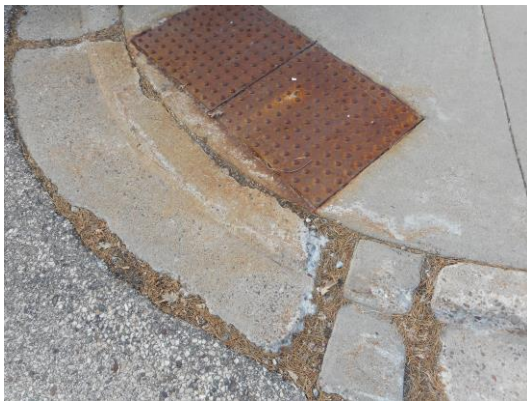
**Photo 4:** The rough condition of the curb ramps includes crumbling concrete and an abrupt transition where the concrete gutter meets the asphalt drive lane.

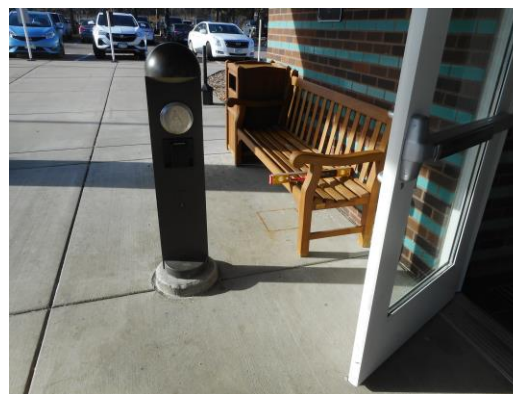
**Photo 5:** A power door operator is provided at the main entry. *This is a good example of accessibility.* The arc of the door swing currently overlaps the clear ground space for the control button and the control button is currently mounted approximately 4" too high (it is mounted on a concrete base, different than City Hall).

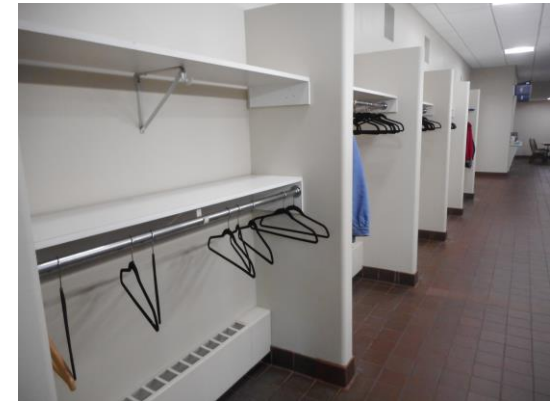
**Photo 6:** The coat closet area near the main entry includes an accessible hanging section. *This is a good example of accessibility.*

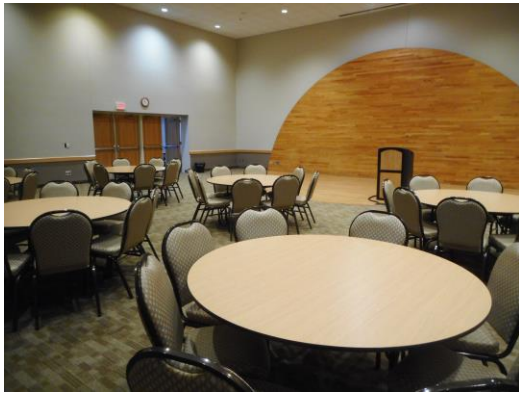
**Photo 7:** The banquet room allows for multiple seating and dining configurations. The tables are a style that allows for a forward approach with knee and toe clearance. *This is a good example of accessibility.*

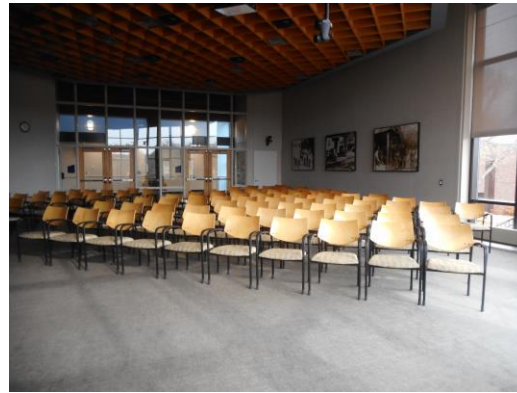
**Photo 8:** The council chambers have movable seating that was arranged to integrate wheelchair seating positions. *This is a good example of accessibility.*  
Confirm the availability of an assistive listening system for this space.

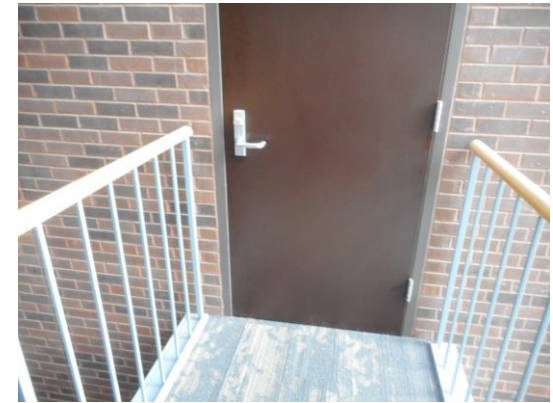
**Photo 9:** There is a catwalk/bridge from the Mayor's office to the member entry to the council chambers. There is not currently maneuvering clearance at the doors on the catwalk/bridge.

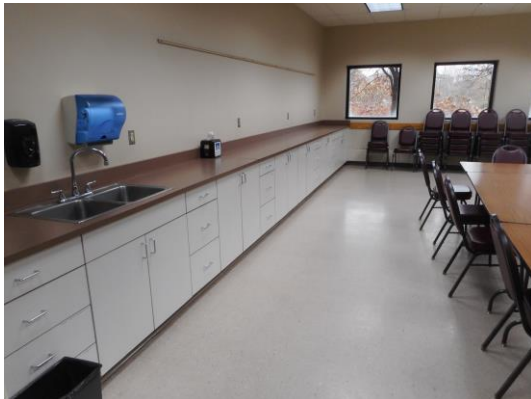
| Location<br>JQP # / Item # | Solution / Comments | Qty | Unit Cost | Total Cost | Priority | Estimated<br>Compl. Date | Person<br>Responsible | Actual<br>Compl.<br>Date | Actual<br>Cost |
|---|--|---|---|---|---|---|---|---|---|
| 27B 27868 | Modify / replace sink and / or counter so rim is no higher than 34".<br>ICC / ANSI 606.3<br><i>The sink is currently at 36 1/4" AFF; it does not currently provide a forward approach with knee and toe clearance. Photo 10.</i> | 1 | \$1,000 | \$1,000 | 3 | | | | |

**Photo 10:** The sink in the Minnetonka Mills room is currently at 36 1/4" (vs. 34" maximum) and does not allow for a forward approach with knee and toe clearance.

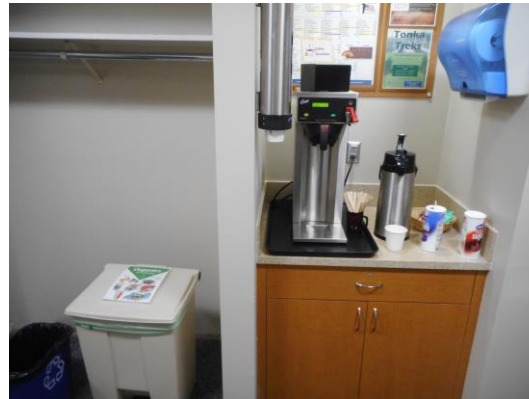
**Photo 11:** A coffee station is provided in passage 151 (outside Minnetonka Mills). Currently most elements are above the maximum reach of 48" AFF, including: coat rack, towel dispenser (at 61 1/2"), cup dispenser (at 54") and hot water dispenser (at 58").

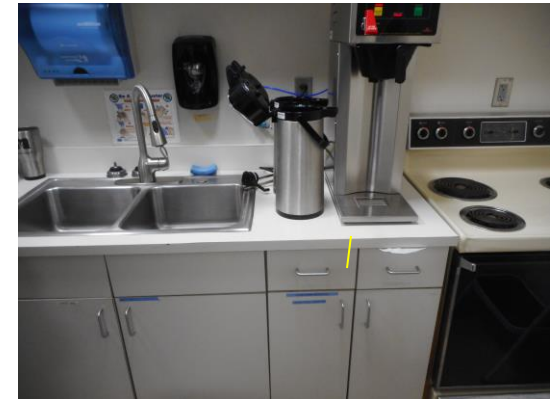
**Photo 12:** A full kitchen (including a range) is currently provided on 2<sup>nd</sup> floor. There are currently no features of accessibility provided within the kitchen. Note- if the range were eliminated there would be fewer accessibility requirements for the kitchenette such as no accessible work surface requirement and a parallel approach would be allowed at the sink.

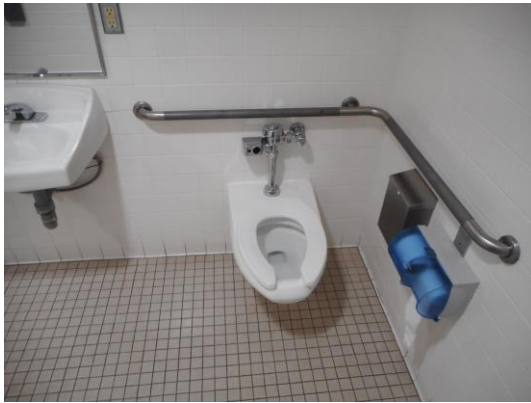
| Location<br>JQP # / Item # | Solution / Comments | Qty | Unit Cost | Total Cost | Priority | Estimated<br>Compl. Date | Person<br>Responsible | Actual<br>Compl.<br>Date | Actual<br>Cost |
|---|---|---|---|---|---|---|---|---|---|
| 22K6 (MN) 27853 | Remove the existing grab bar configuration and replace with a compliant grab bar configuration.<br>MN 1341 604.5.1 ANSI 604.5.2<br><i>There is currently a continuous bar from the wall behind the toilet to the side wall adjacent to the toilet. The side wall grab bar does not currently extend to a point 54" from the rear wall and there is not a vertical grab bar. It will be necessary to remove the existing grab bars in order to install a compliant horizontal grab bar on the side wall. Photo 13.</i> | 1 | \$500 | \$500 | 2 | | | | |

**Photo 13:** A single-user toilet room is provided on 1<sup>st</sup> floor adjacent to the elevator. This room provides many features of accessibility, but does not fully comply with current requirements at this time. Additional modifications include replacing the grab bars and relocating the lavatory to outside the toilet clearance.

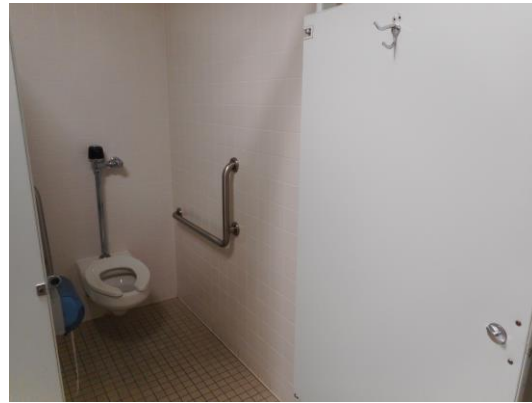
**Photo 14:** The multi-fixture toilet rooms currently provide minimal features of ambulatory accessibility. Providing a wheelchair accessible compartment in these rooms would require the elimination of fixtures, which may not be possible due to other code requirements.

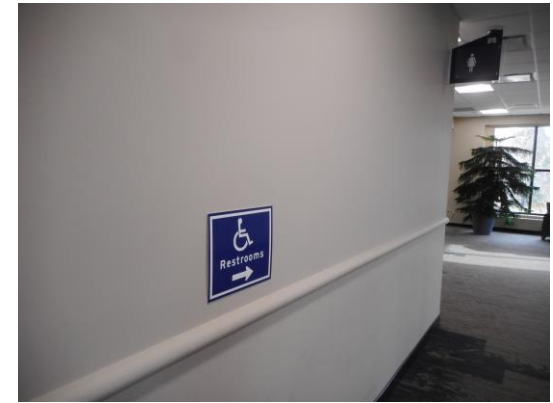
**Photo 15:** Near the 2<sup>nd</sup> floor toilet rooms signs directing to accessible toilet rooms have been posted. The signs are directing to the toilet rooms located in City Hall. Additional details could be included to provide users more information about the location of the toilet rooms as well as directing to the 1<sup>st</sup> floor single-user toilet room.

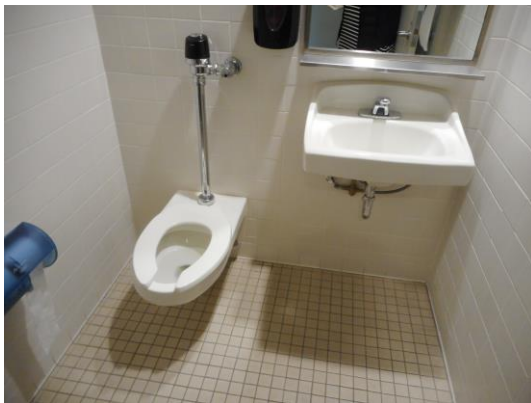
**Photo 16:** There are additional single-user toilet rooms located near the Mayor's office and in the kitchen area. These single-user toilet rooms currently provide no features of accessibility and are too small to provide compliant clearances at fixtures.

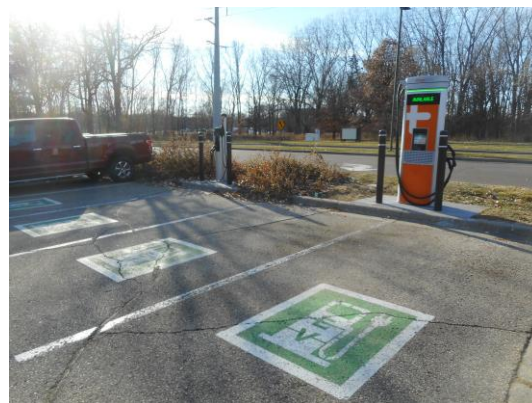
| Location<br>JQP # / Item # | Solution / Comments | Qty | Unit Cost | Total Cost | Priority | Estimated<br>Compl. Date | Person<br>Responsible | Actual<br>Compl.<br>Date | Actual<br>Cost |
|---|--|---|---|---|---|---|---|---|---|
| <i>There is not currently an aisle associated with either of the EV charging stations; providing an aisle is recommended based on anticipated code changes that will specifically address EV charging as well as guidance from the US Access Board. Photo 17.</i> | | | | | | | | | |

**Photo 17:** There are currently 4 EV charging spaces located along the west perimeter of the parking lot (2 different style charging stations). There is not currently an accessible route to the charging station and none of the spaces currently has an adjacent aisle.
